Cost-Effective Elastomeric Roof Coating System

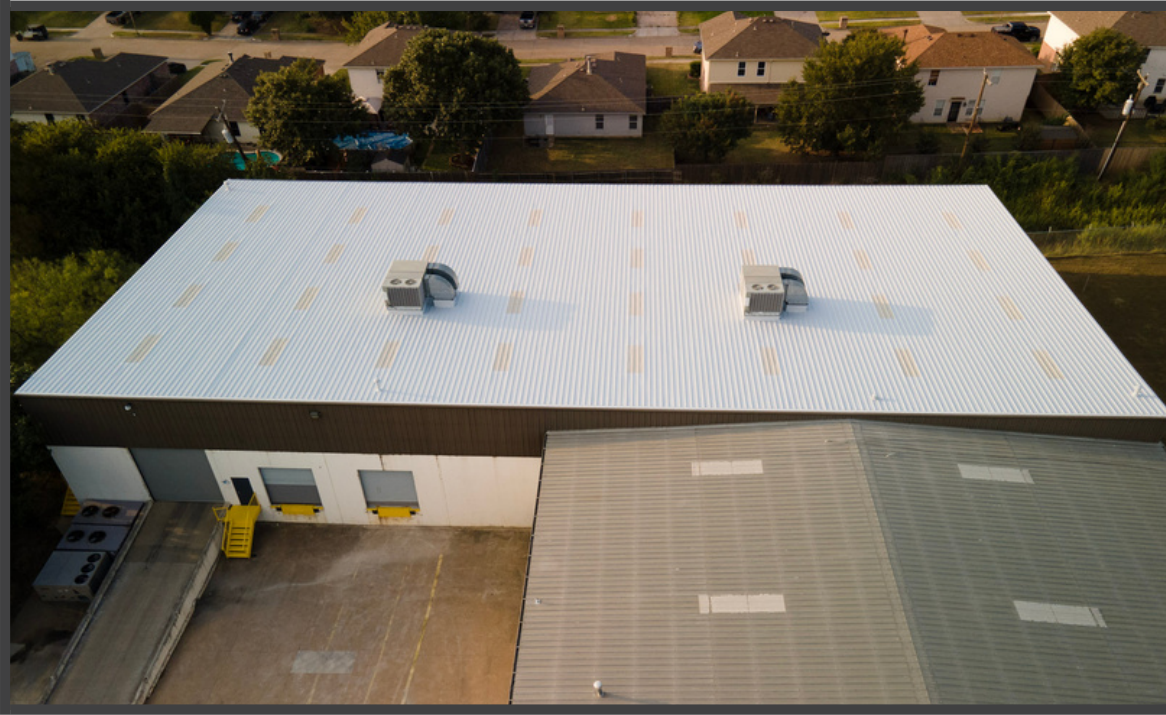
The new owner purchased the building with pre-existing hail damage to the R-panel metal roof. The damage was too old to submit a claim with insurance & the building was not in our customer's ownership at the time of loss. Our customer needed a cost effective method to stop leaks and extend the roof system's life

Apply a 10-year elastomeric roof coating system from Everest. Our scope was to de-scale the R-panel roof and damaged panels, trim, and gutters. Seal all bolts, horizontal & vertical seams, penetrations, and curbs. The existing skylights were to receive an evident coat seal. After the roof system was prepped, we would proceed with an application of a two-coat elastomeric roof coating system.

Aesthetically the roof looks great, but functionally it's performing even better. The leaks have been eliminated, and the warehouse space is cooler than it was with the old R-panel system alone. The building owner is satisfied with the finished product and will likely apply a similar system to the front portion of the building in the near future.
