CASE STUDY

COMMERCIAL | BUSINESS BUILDING

ELASTOMERIC COATING

EVERCOAT EC WHITE

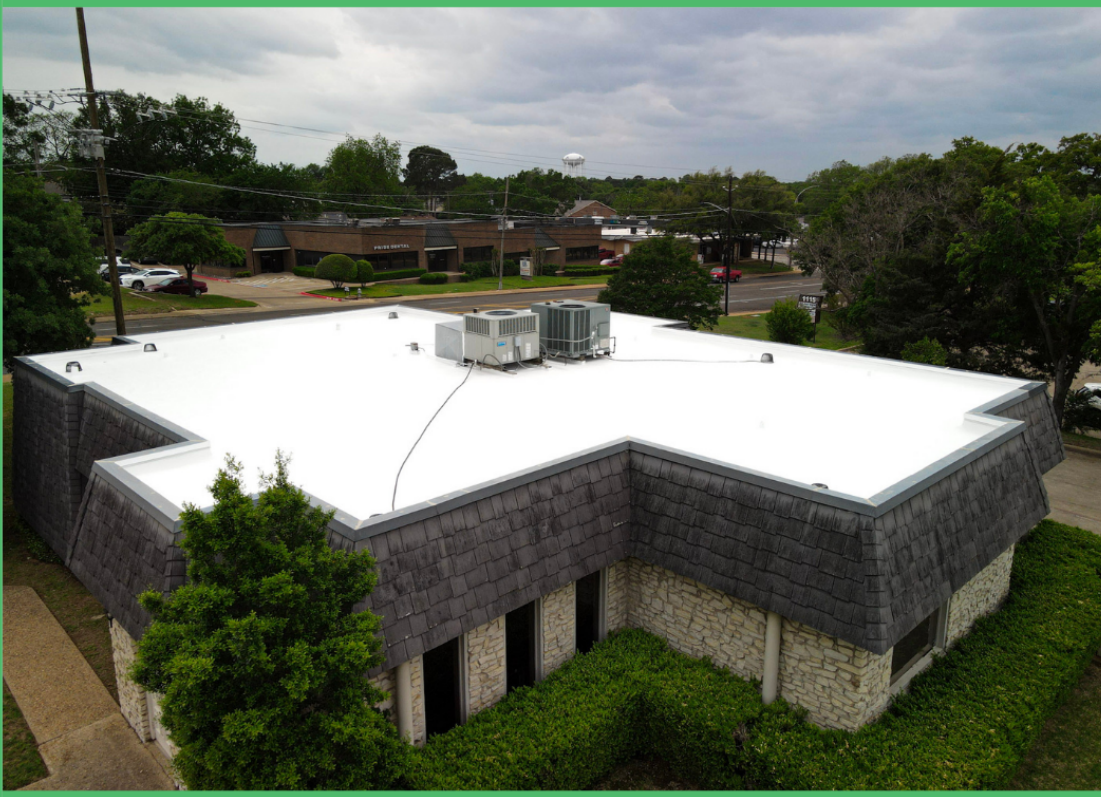
The customer had an aging building with an old, failing modified bitumen roof. Attempts were made to repair the roof, but they only lasted a year or two due to the age and condition of the old roof. The owner only had two options to alleviate the problems because there were already two roofing layers on the building.

The customer chose option #2 for many reasons, the main one being price. The new roof system would cost +/- \$35,000.00. The new roof coating was under \$10,000. Our crews cleaned the roof of any loose debris, power washed the surface and the parapet walls then sealed around any penetrations and lap joints. We then sprayed an elastomeric roof coating on the entire roof and added new drain baskets. This system, properly maintained, should last at least 10+ years. At that time, we recommend washing it and applying another coat of elastomeric roof coating.

The building is now protected for the next ten years with a beautiful, new bright white roof. The leak problems have been resolved, and the white coating will cool the building down considerably- allowing the HVAC system to function more efficiently.
